Manhole Inspection Summary

Manhole # S37WW_033MH

Insp Date: **1/4/07 9:05 AM**

Location Address: **414 31ST**

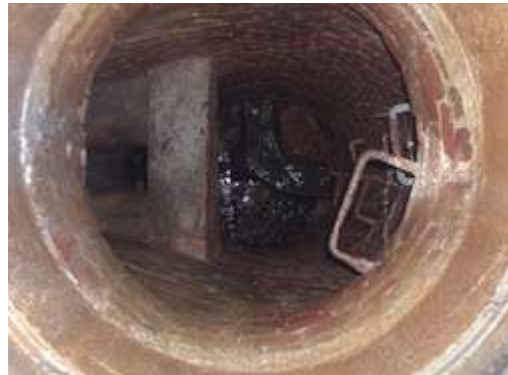
Top View

Barrel infiltration. Corroded steps. Bench debris.

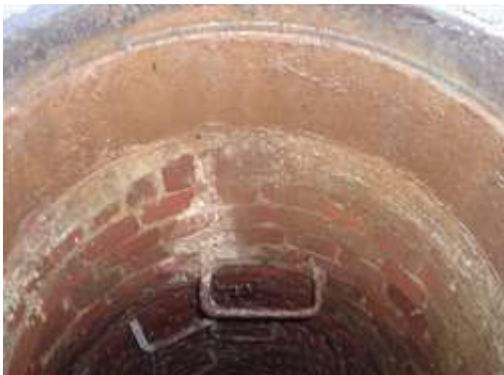
Defect

Frame leaks. Adjustment and Corbel infiltration.

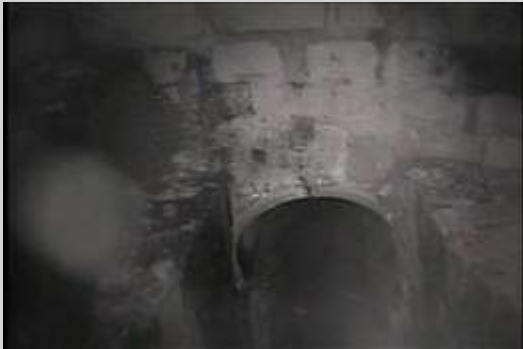
12 in. Circular Gravity Sewer Pipe Out @ 12 O'Clock

Invert Depth: **15.54** (ft.) Flow Characteristics: **Slow**

Infiltration: **None** Pipe Seal Cond: **Sound**

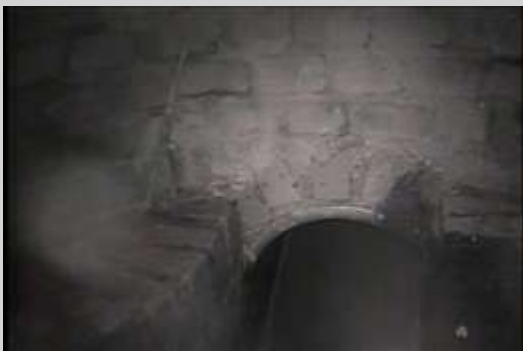
12 in. Circular Gravity Sewer Pipe In @ 3 O'Clock

Infiltration: **Evidence** Pipe Seal Cond: **Sound**

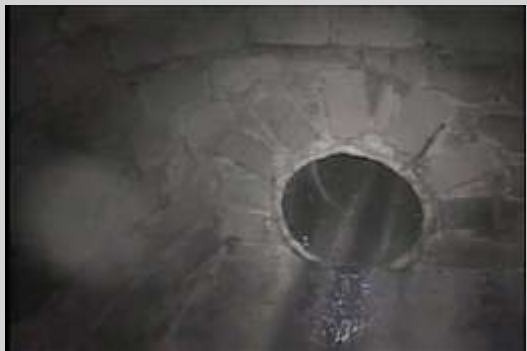
Pipe In @ 9 O'Clock

Deposits: ☐ None ☐ Mud ☒ **Sludge** ☐ Debris ☐ Grease

Silt Depth: **2** (in.) Deposits Extent: **Light**

Infiltration: **Evidence** Pipe Seal Cond: **Sound**
